INDIANA DAM SAFETY INSPECTION MANUAL

UPDATED 2007

PART 3 DAM SAFETY INSPECTIONS

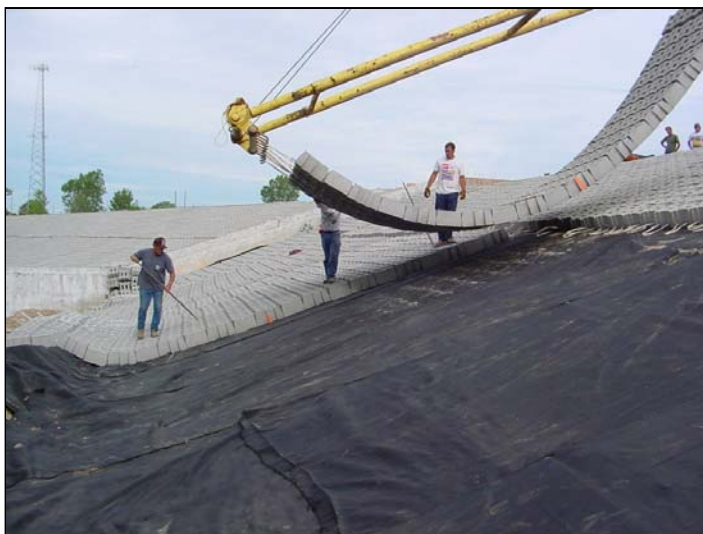
Figure 6-41 Articulating blocks are being placed over a geotextile filter on a dam embankment.

Geotextiles serve to control or prevent the movement of soil fines under riprap or similar materials used for slope protection and for lining spillways and plunge pools. Punctures and other deficiencies may result in loss of bedding material and erosion of foundation material beneath the geotextile, leading to sunken areas and voids under the riprap.

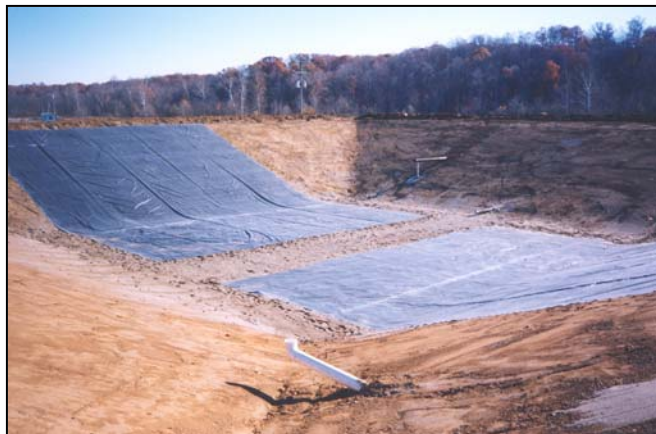
Figure 6-42 A geomembrane liner being installed in a waste water reservoir.

For reservoirs sealed with a geomembrane liner, unaccountable losses from the reservoir may be the first clue that the liner is leaking. Seepage around the reservoir rim is another indicator. The inspector should examine the reservoir floor with the reservoir drawn down if possible. Examine the protective layer over the membrane liner for gaps, plant growth, animal burrows, damage from vandalism, and piercing of the liner.

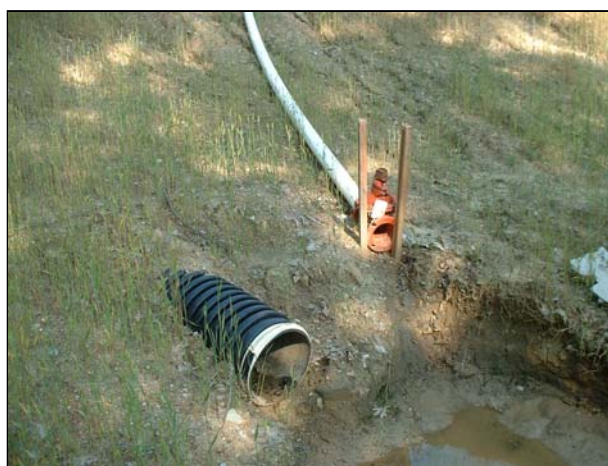
Figure 6-43 Plastic pipe used as the principal spillway; the use of this type of pipe is not recommended

If plastic pipes are used in any application at a dam or reservoir, a detailed engineering analysis of the application must be performed and installation techniques must be carefully specified. Only “thick-walled” plastic pipe should be considered for use, and IDNR or a qualified dam safety professional should be consulted prior to its use. In general, the use of plastic pipe for spillway discharge conduits is not recommended.

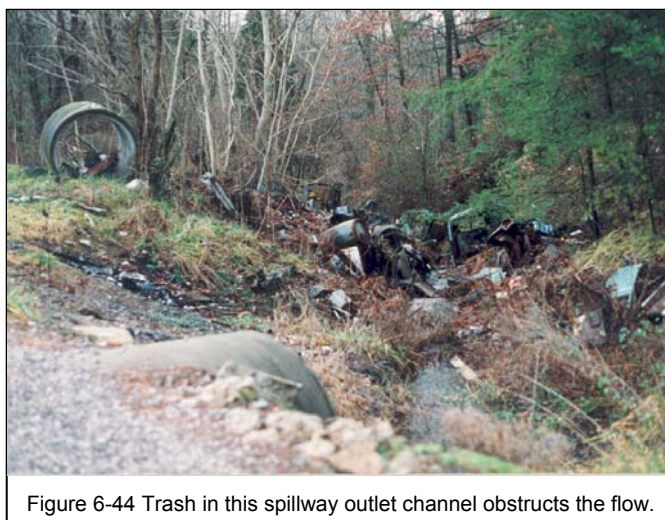
Figure 6-44 Trash in this spillway outlet channel obstructs the flow.

Earthen emergency spillways are particularly prone to excessive vegetative growth. There should be no trees, shrubs, or brush in any emergency spillway. Man-made structures, unless considered in the original design for spillway adequacy, should not be built in emergency spillways. The inspector should always recommend the removal of trees, shrubs, and other obstructions in the emergency spillway. Figure 6-44 shows a spillway discharge channel with excessive trash. Figure 6-45 shows a building constructed in an emergency spillway.

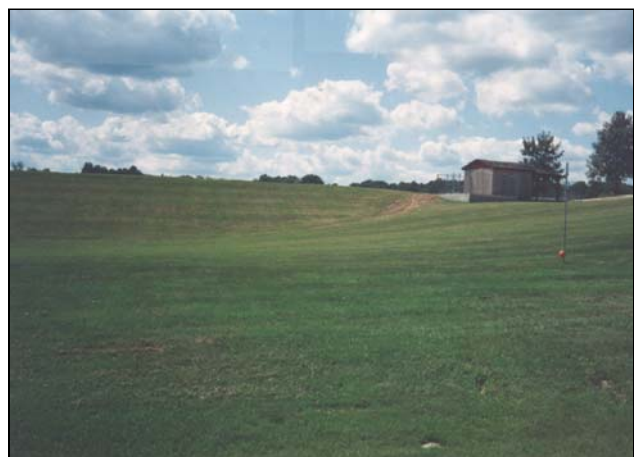
Figure 6-45 A building constructed in the emergency spillway obstructs flow and poses a safety risk to the building.

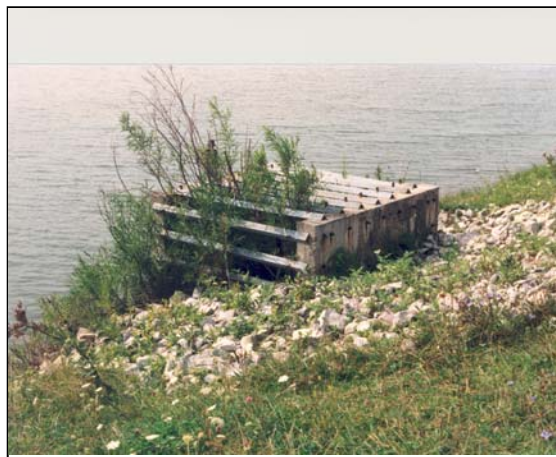
Figure 6-46 Excessive vegetation obstructs this riser structure.

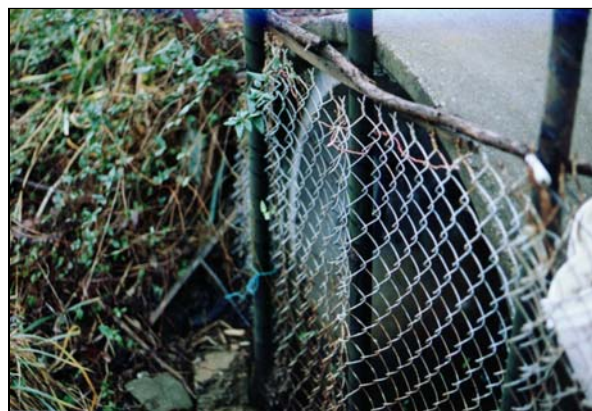
Figure 6-47 Inappropriate trash rack over end of a culvert spillway.

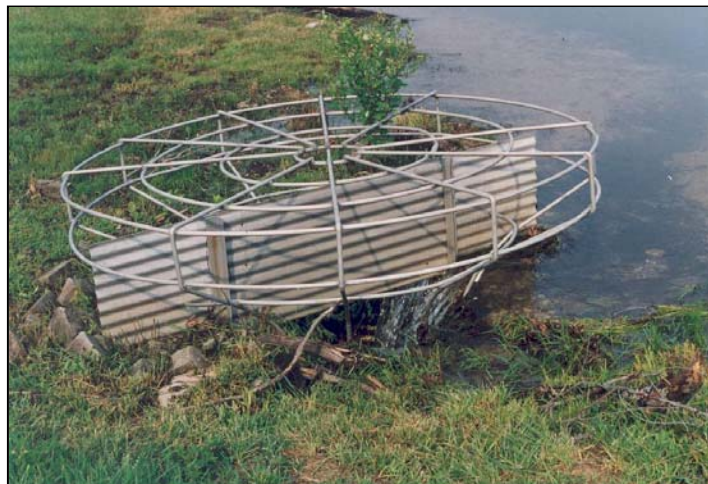
Figure 6-48 Poorly constructed trash rack has openings that are too large at the riser crest.

A well-designed trash rack will stop large debris that could plug the discharge pipe but allow unrestricted passage of water and smaller debris. Some of the most effective racks allow flow to pass beneath the trash into the riser inlet as the pool level rises. Racks usually become plugged because the openings are too small, or the head loss at the rack causes material and sediment to settle out and accumulate. Small openings will stop small debris such as twigs and leaves, which in turn cause a progression of larger items to build

up, eventually completely blocking the inlet. Trash rack openings should be at least 6 inches across regardless of the pipe size. The larger the principal spillway conduit, the larger the trash rack opening should be. The largest possible openings should be used, up to a maximum size of about 2 feet.

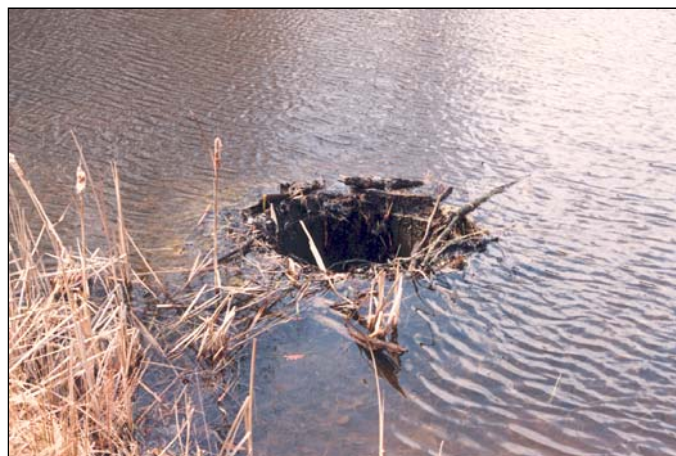
Figure 6-49 Riser lacking a trash rack can clog and cause dam overtopping.

The lack of a trash rack is unacceptable, and creates the potential for an extremely hazardous condition. Trash racks constructed from very thin wire, such as “chicken wire,” that can be easily damaged or destroyed is also unacceptable. Trash racks that are “flat” and cover only the opening of a riser (i.e. constructed similar to a grate over a drop inlet on streets) are also safety concerns because of the potential for clogging. In either case, the inspector should recommend the installation of a proper trash rack.

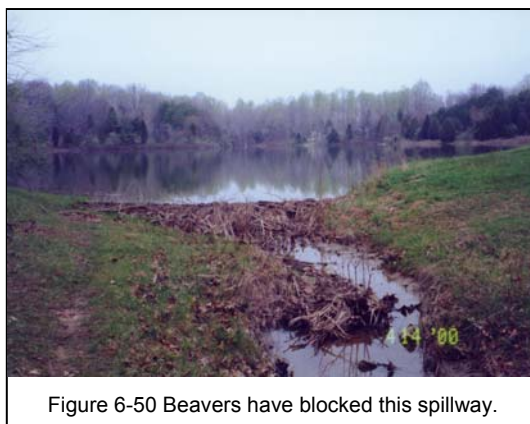
Figure 6-50 Beavers have blocked this spillway.

Beavers may present problems at dams where they may live since they have a natural tendency to block off spillways with brush and sticks. Beavers are attracted to the sound of running water and tend to build dams where they hear this sound. Beavers should be eliminated or relocated if they become a problem, or a control device should be constructed at the spillway to prevent their approach.

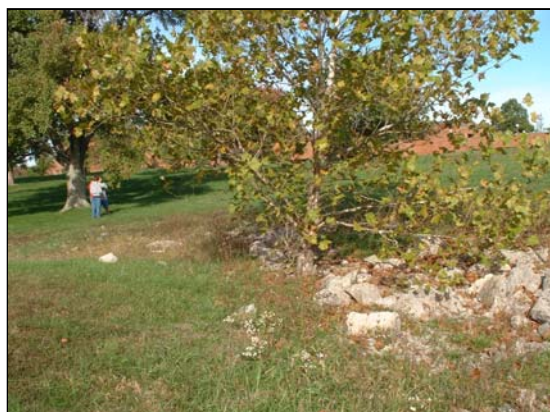
Figure 6-51 Trees growing in emergency spillway.

Periodic mowing in the grass-lined spillways is required to prevent trees, brush, and weeds from becoming established, and to encourage the growth of grass. Poor vegetal cover will usually result in extensive, rapid erosion when the spillway flows, and will require more costly repairs. Trees and brush may reduce the discharge capacity of the spillway. The inspector should evaluate the degree of vegetative growth in the earthen spillways. Tree and shrub removal should always be recommended if these plants are present.

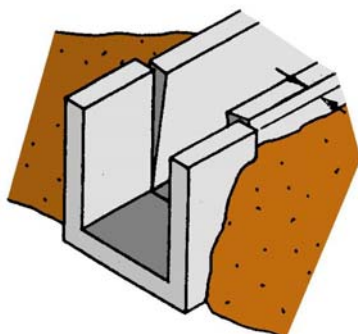
PROBLEMS**WALL DISPLACEMENT**

Poor workmanship; uneven settlement of foundation; excessive earth and water pressure; insufficient steel bar reinforcement of concrete.

Minor displacement will create eddies and turbulence in the flow, causing erosion of the soil behind the wall. Major displacement will cause severe cracks and eventual failure of the structure.

Reconstruction or replacement should be done according to sound engineering practices. Foundation should be carefully prepared. Adequate weep holes should be installed to relieve water pressure behind wall. Use sufficient reinforcement in the concrete. Anchor walls to prevent further displacement. Install struts between spillway walls is required. Clean out and backflush drains to assure proper operations. Consult an engineer before actions are taken.

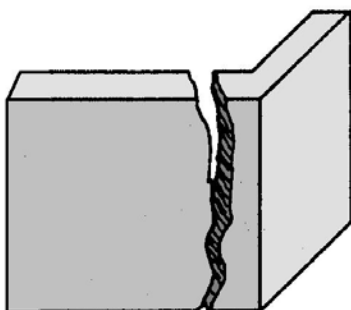
LARGE CRACKS

Construction defect; local concentrated stress; local material deterioration; foundation failure, excessive backfill pressure.

Disturbance in flow patterns; erosion of foundation and backfill; eventual collapse of structure.

Large cracks without large displacement should be repaired by patching. Surrounding areas should be cleaned or cut out before patching material is applied. Installation of weep holes or other actions may be needed.

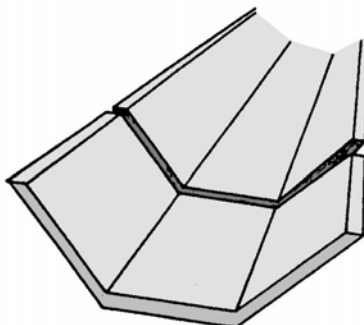
OPEN OR DISPLACED JOINTS

Excessive and uneven settlement of foundation; sliding of concrete slab; construction joint too wide and left unsealed. Sealant deteriorated and washed away.

Erosion of foundation material may weaken support and cause further cracks; pressure induced by water flowing over displaced joints may wash away wall or slab, or cause extensive undermining.

Construction joint should not be wider than 0.5 inches. All joints should be sealed with asphalt or other flexible materials. Water stops should be used where feasible. Clean the joint, replace eroded materials, and seal the joint. Foundation should be properly drained and prepared. Underside of chute slabs should have ribs of sufficient depth to prevent sliding. Avoid steep chute slope.

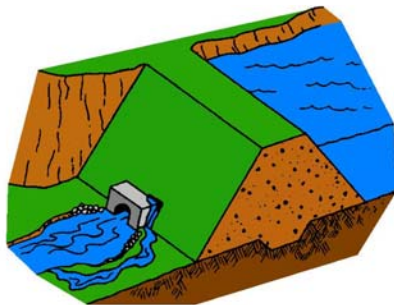
PROBLEMSSEEPAGE WATER EXITING FROM A POINT
ADJACENT TO THE OUTLET

1. A break in the outlet pipe.
2. A path for flow from the reservoir has developed along the outside of the outlet pipe.

Continued flows can lead to rapid erosion of embankment materials and failure of the dam.

1. Thoroughly investigate the area by probing and/or shoveling to see if the cause can be determined.
2. Determine if leakage water is carrying soil particles.
3. Determine quantity of flow.
4. If flow increases or is carrying embankment materials, reservoir level should be lowered until leakage stops.
5. A qualified engineer should inspect the condition and recommend further actions to be taken.

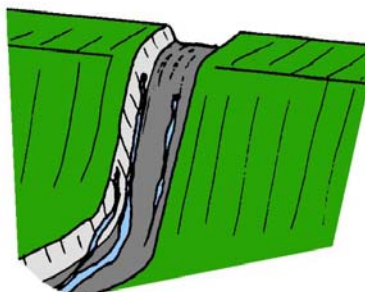
LEAKAGE IN OR AROUND SPILLWAY

1. Cracks and joints in geologic formation at spillway are permitting seepage.
2. Gravel or sand layers at spillway are permitting seepage through embankment.

1. Could lead to excessive loss of stored water.
2. Could lead to a progressive failure if velocities are high enough to cause erosion of natural materials.

1. Examine exit area to see if type of material can explain leakage.
2. Measure flow quantity and check for erosion of natural materials.
3. If flow rate or amount of eroded materials increases rapidly, reservoir level should be lowered until flow stabilizes or stops.
4. A qualified engineer should inspect the condition and recommend further actions to be taken.

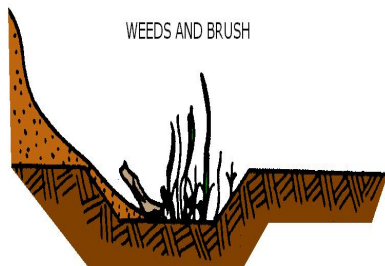
PROBLEMS**CAUSES & HARM DONE****ACTION REQUIRED****DEBRIS OR OTHER OBSTRUCTIONS**

Accumulation of slide materials, dead trees, excessive vegetative growth, etc., in spillway channel.

Reduced discharge capacity; overflow of spillway; overtopping of dam. Prolonged overtopping can cause failure of the dam.

Clean out debris periodically; control vegetative growth in spillway channel. Install log boom in front of spillway entrance to intercept debris.

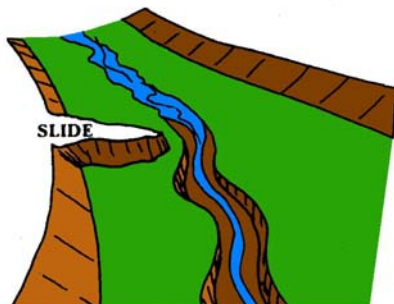
EXCESSIVE EROSION IN EARTH-SLIDE CAUSES CONCENTRATED FLOWS

1. Discharge velocity too high; bottom and slope material loose or deteriorated; channel and bank slopes too steep; bare soil unprotected; poor construction; protective surface failed.

Disturbed flow pattern; Loss of material, increased sediment load downstream; collapse of banks; failure of spillway; can lead to rapid evacuation of the reservoir through the severely eroded spillway.

Minimize flow velocity by proper design. Use sound material. Keep channel and bank slopes mild. Encourage growth of grass on soil surface. Construct smooth and well compacted surfaces. Protect surface with riprap, asphalt, or concrete. Repair eroded portion using sound construction practices.

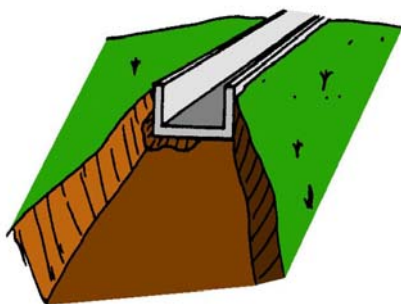
END OF SPILLWAY CHUTE UNDERCUT

Poor configuration of stilling basin area. Highly erodible materials. Absence of cutoff wall at end of chute.

Structural damage to spillway structure; collapse of slab and wall; leads to costly repair. Higher velocity flows can cause erosion of drain, then embankment materials.

Dewater affected area; clean out eroded area and properly backfill. Improve stream channel below chute; provide properly sized riprap in stilling basin area. Install cutoff wall.

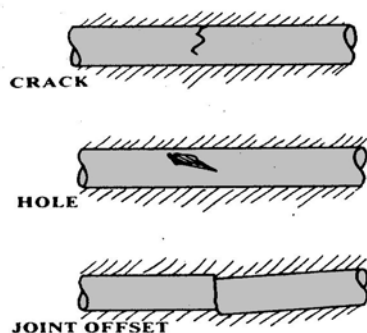
PROBLEMS**OUTLET PIPE DAMAGE**

Settlement; impact, improper design or placement.

Check for evidence of water either entering or exiting pipe at crack/ hole/etc.

Tap pipe in vicinity of damaged area, listening for hollow sound which indicates a void has formed along the outside of the conduit.

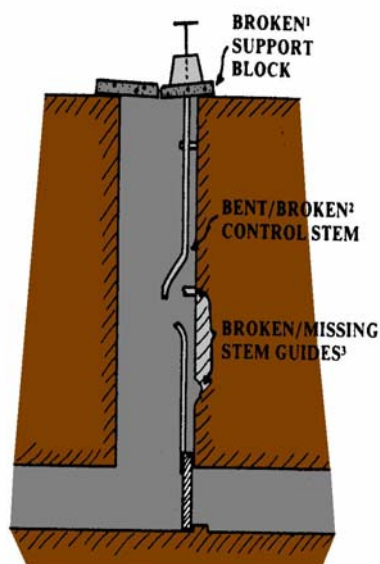
CONTROL WORKS

**1. BROKEN SUPPORT BLOCK:****Probable Cause:**

Concrete deterioration. Excessive force exerted on control stem by attempting to open gate when it was jammed.

Causes control support block to tilt; control stem may bind. Control headworks may settle. Gate may not open all the way. Support block may fail completely, leaving outlet inoperable.

Rust. Excess force used to open or close gate. Inadequate or broken stem guides.

Loss of support for control stem. Stem may buckle and break under even normal use, (as in this example).

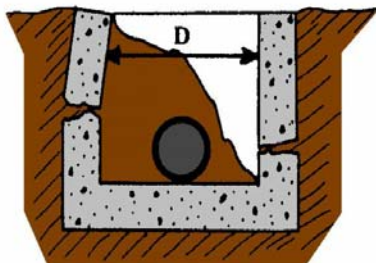
PROBLEMS**FAILURE OF CONCRETE OUTFALL STRUCTURE**

Excessive side pressures on non-reinforced concrete structure. Poor concrete quality.

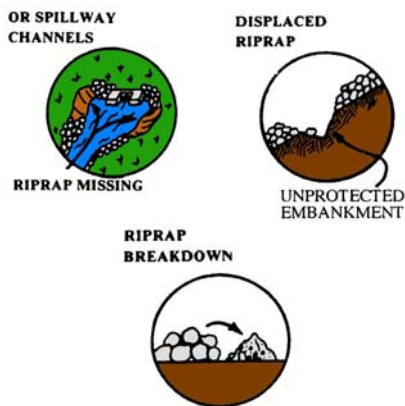
Breakdown or loss of riprap

Slope too steep; material poorly graded; failure of sub-grade; flow velocity too high; improper placement of material; bedding material or foundation washed away.

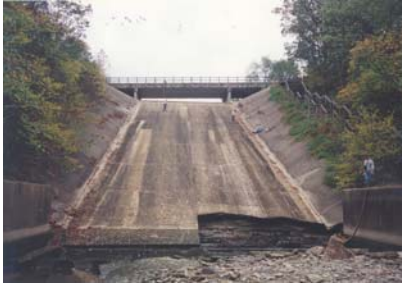
Concrete erosion, abrasion, and fracturing

1. Flow velocity too high (usually occurs at lower end of chute in relatively high dams); rolling of gravel and rocks down the chute; cavity behind or below concrete slab.
2. Absence of cutoff wall.

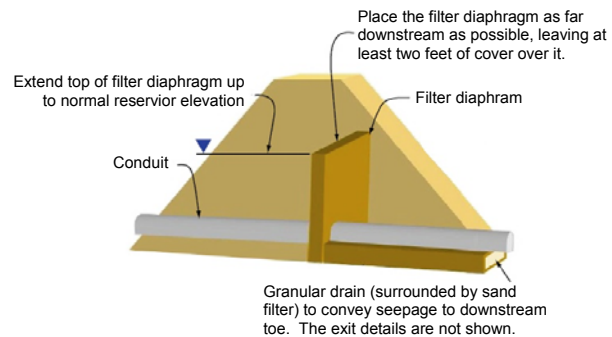
SAND FILTER DIAPHRAGM (TYPICAL CONFIGURATION)

The preferred method of seepage control. Prevent seepage water from removing soil from around conduit. Commonly connected to a horizontal granular layer or pipe drain to convey seepage from the diaphragm away from the embankment.

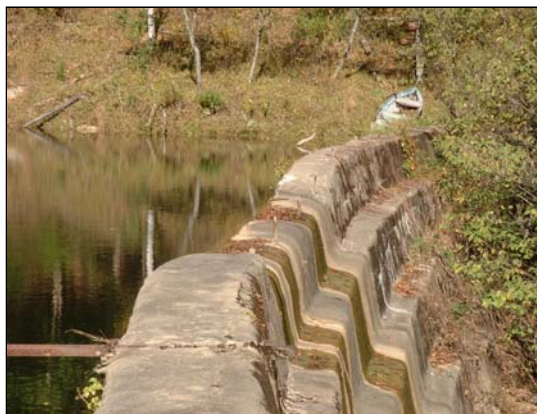
Figure 7-1 A concrete gravity dam in Indiana.

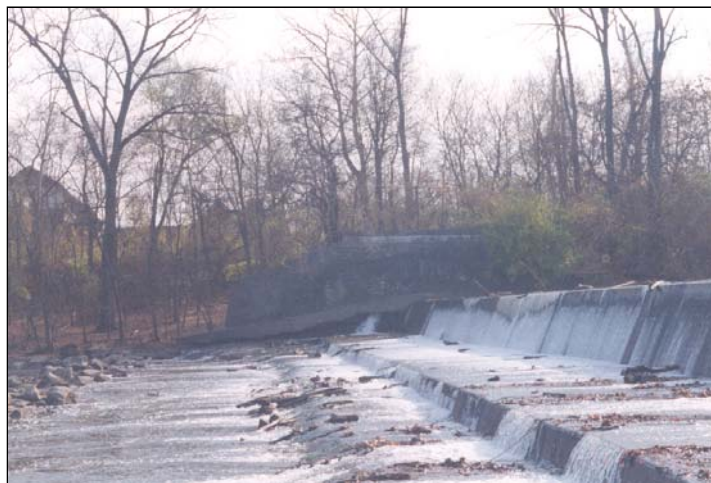
Figure 7-2 Most concrete dams in Indiana are in-channel structures that are difficult to inspect.

difficult to inspect because they are continuously inundated with overflow, and typically have a lot of debris on the structure (see Figures 7-2 and 7-3). Sometimes these concrete structures are contained in or along earth embankments.

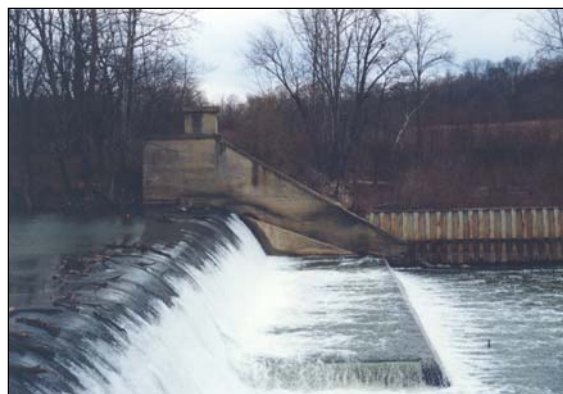
Figure 7-3 Low head, in-channel concrete dams are very dangerous due to the whirlpools, hydraulic jumps, and eddies on the discharge side.

drowning accidents that have occurred in such areas. It can be very difficult or impossible for swimmers and boats to escape from this area, especially during periods of increased flow following precipitation events. For this reason, these dams are often referred to as “drowning machines.”

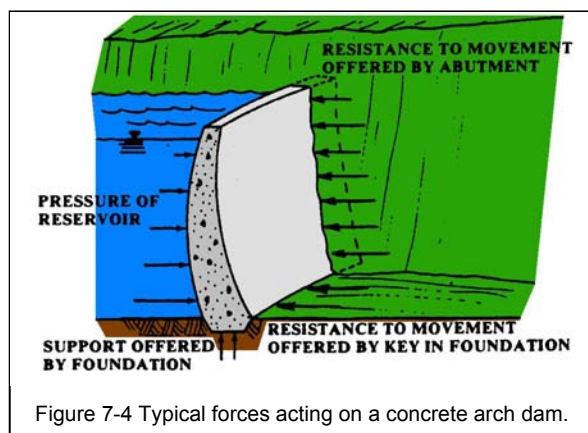
Figure 7-4 Typical forces acting on a concrete arch dam.

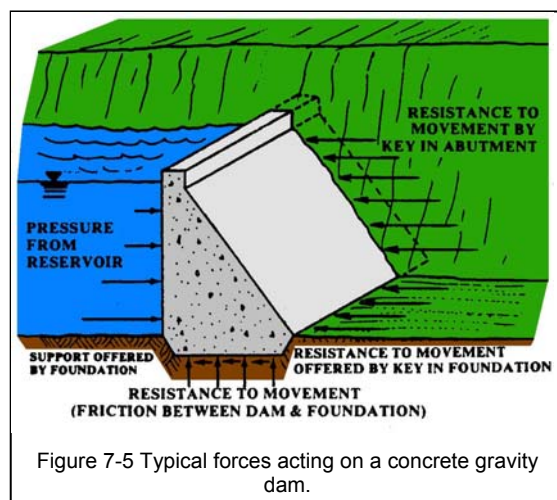
Figure 7-5 Typical forces acting on a concrete gravity dam.

The principal items that are potentially hazardous at concrete dams are structural cracking, foundation or abutment weakness, and deterioration. The water in the reservoir exerts substantial hydrostatic forces on the concrete structure, and the concrete structure exerts very large forces on the foundations and abutments.

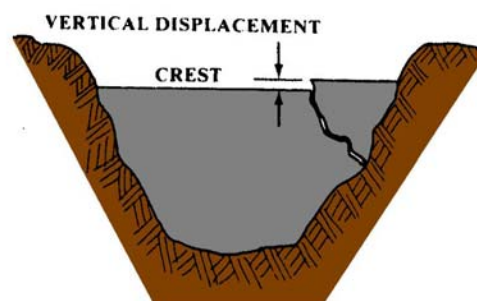
Figure 7-7 Foundation settlement or piping may lead to structural cracking with vertical displacement.

Structural cracks are caused by overstressing of portions of the dam, and are usually caused by inadequate design, poor construction techniques, or faulty materials. Structural cracks are often irregular, meaning they run at an angle to the major axes of the dam and may exhibit abrupt changes in direction. These cracks may also have noticeable radial, transverse, or vertical displacement. Overstressing in a concrete dam normally creates areas of distress and cracking that usually can be identified visually during a visual inspection. Cracking, opening of construction joints, changes in leakage rates, and differential movements are all indications of possible overstressing. The overstressing may occur along the foundation because of differential or extreme foundation movements or at any location in the concrete mass of a dam where stresses are excessive. The overstressing may be due to unusual external loading conditions, temperature variations, contraction joint grouting pressures, foundation movement, or excessive uplift pressure in the foundation or along unbonded lift lines.

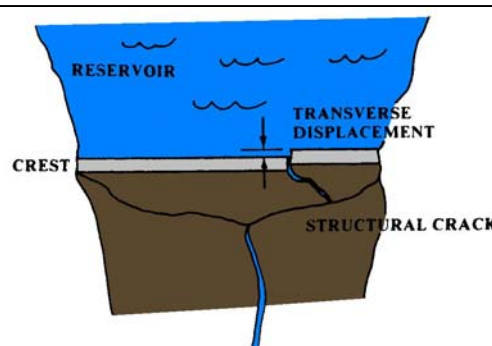
Figure 7-8 Structural crack with transverse displacement and significant seepage.

Leakage through cracks in concrete dams, although unsightly, is not usually dangerous, unless accompanied by structural cracking. The worst effect may be to promote minor deterioration due to the elements through freeze-thaw action. Increases in seepage could indicate that materials are being leached from the dam and carried away by the flowing water. Decreases in seepage may also occur as mineral deposits are formed in the seepage channel. In neither case is the condition inherently dangerous. Detailed analysis of the problem may be required before it can be determined that repair is necessary for other than cosmetic reasons.

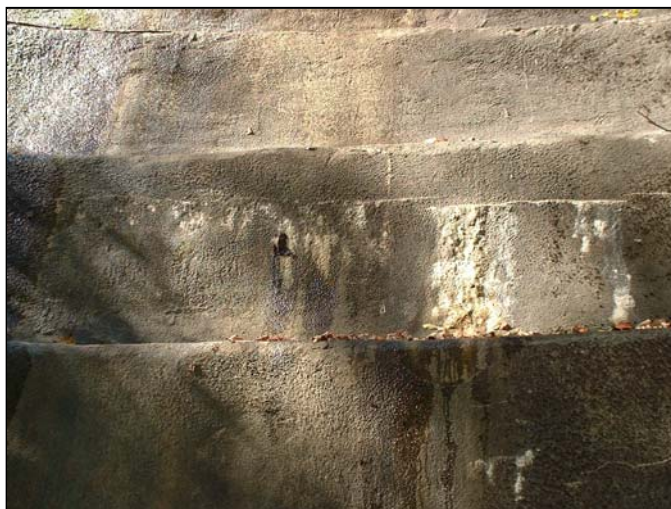
Figure 7-11 Calcium carbonate deposits on the downstream face of a concrete dam as a result of water seepage.

Deterioration of concrete may be caused by many factors, including weathering, mechanical impacts, internal pressure, drying shrinkage, thermal stress, chemical action, leaching by water seepage, poor concrete mixes, poor concrete design, and freeze-thaw action. Water seeping through cracks in concrete usually leaches calcium from the concrete and forms white, calcium carbonate deposits on the concrete

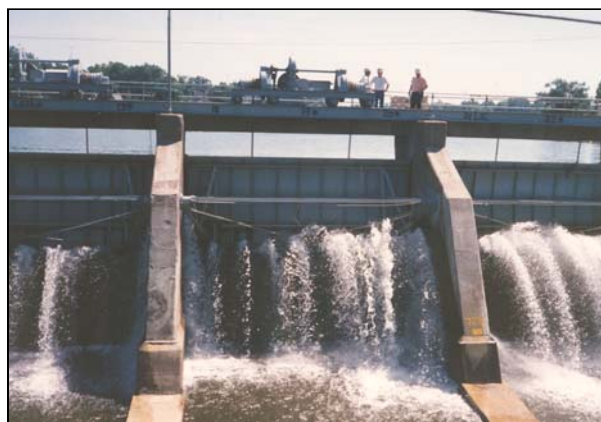
Figure 7-12 Concrete dams are usually difficult to inspect.

The faces of concrete dams are often near vertical, and the site is commonly a steep-walled rock valley. Access to the downstream face, toe area, and abutments may be difficult and usually requires special safety equipment such as safety ropes, or a boatswain's chair. Close visual inspection of the upstream face may also require a boatswain's chair or a boat. Without this equipment, visual inspection of all surfaces of the dam and abutments may not be possible.

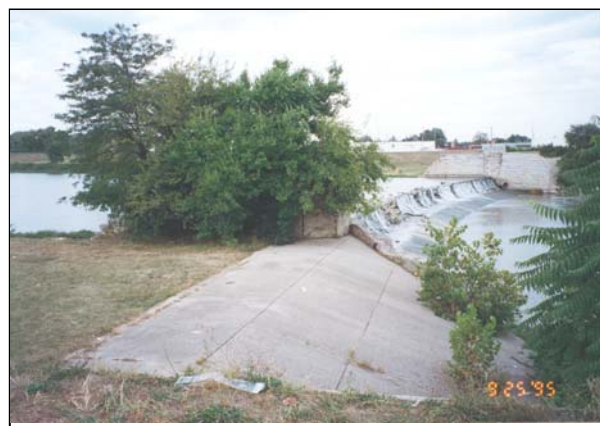
Figure 7-13 Access to this in-channel concrete dam is dangerous.

A boat may be required to access the upstream face that is above the water. In-channel dams such as low head dams, and areas downstream of large outfalls are very dangerous and require extreme caution during visual inspections. The high velocity water current, whirlpools, hydraulic jumps, and eddies that form in these areas can create conditions that trap and sink boats and swimmers. The inspector should always wear life preserver jackets when using a boat. Experienced scuba divers are required if the submerged portion of the upstream face must be inspected. Radio

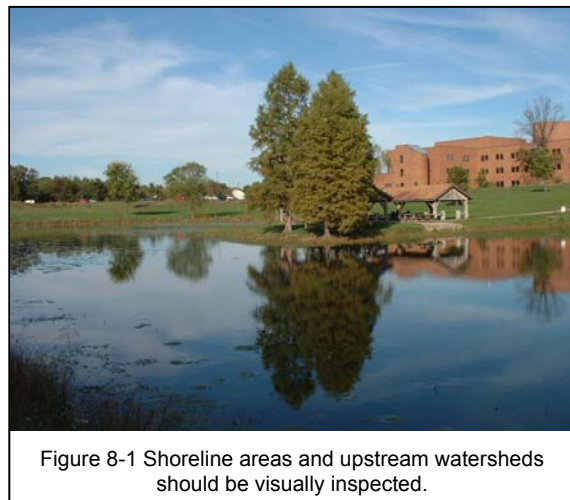
Figure 8-1 Shoreline areas and upstream watersheds should be visually inspected.

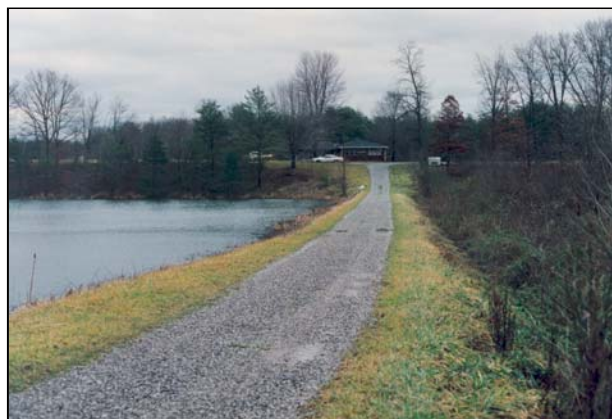
Figure 8-2 This dam has access to and over the embankment, however it may not be able to support heavy equipment.

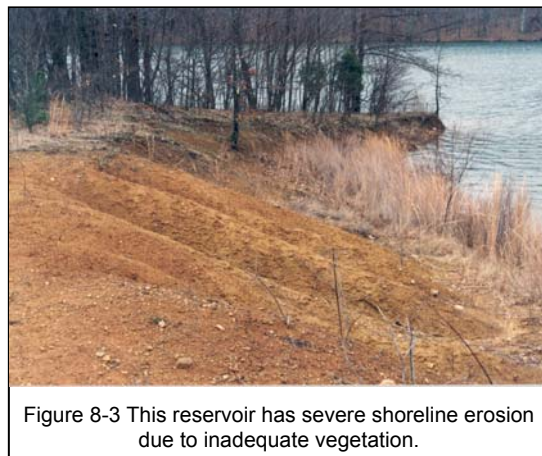
Figure 8-3 This reservoir has severe shoreline erosion due to inadequate vegetation.

The shoreline and reservoir area should be checked for erosion, landslides, cracks, whirlpools, debris, burrowing animals, sediment buildup, and man-made changes and structures along the shore. Landslides into the reservoir can reduce the storage capacity which, in the worst case, may cause the dam to overtop during severe storm events. Signs of landslides include embankment cracking, scarps, and sloughs. Steep slopes along the shoreline are particularly vulnerable to slides. The inspector should also look for sign of seepage from slope areas. Whirlpools may indicate leaks or piping in the bottom of reservoir or along submerged outlets. Burrowing animals should be monitored because they may migrate to the embankment area where they may cause serious harm. Erosion along the shoreline will result in additional sediment entering the reservoir and filling up water space, as well as reducing the available reservoir area.

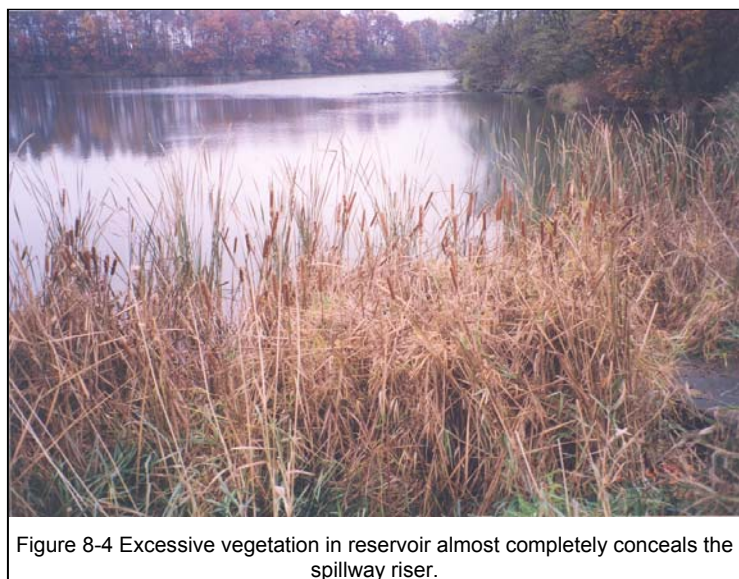
Figure 8-4 Excessive vegetation in reservoir almost completely conceals the spillway riser.

The reservoir submerged areas should be checked for sediment (when possible), debris, and excessive vegetative growth, including algae. Sediment from upstream areas is an ongoing problem in most reservoirs, and is very difficult, if not impossible to stop. When sediment deposits become severe, they should be removed; the usual method is dredging. Although sediment buildup is a concern because it diminishes the value and use of the reservoir, it normally does not affect the dam's stormwater

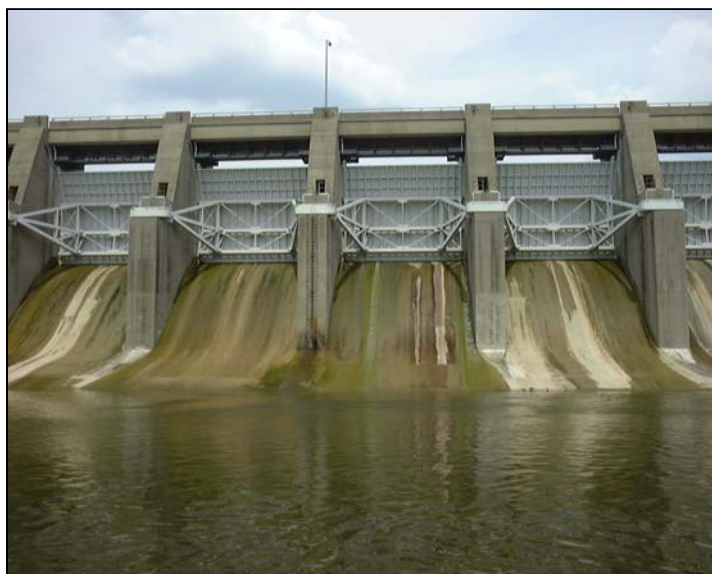
Figure 8-5 Downstream view of gates on a central-Indiana dam.

If the dam or reservoir includes mechanical and electrical features, they should be inspected for disrepair and deterioration. This includes items previously discussed, including spillway gates, sluice gates or valves, stoplogs, flashboards, relief wells, and siphons. It also includes emergency power sources, guardrails along roads, signage,

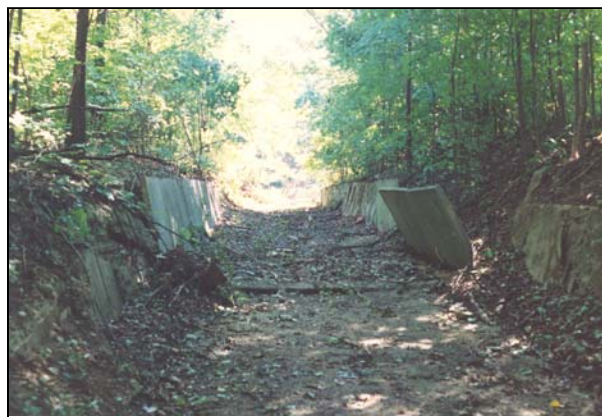
Figure 8-6 Badly deteriorated wall along spillway discharge channel.

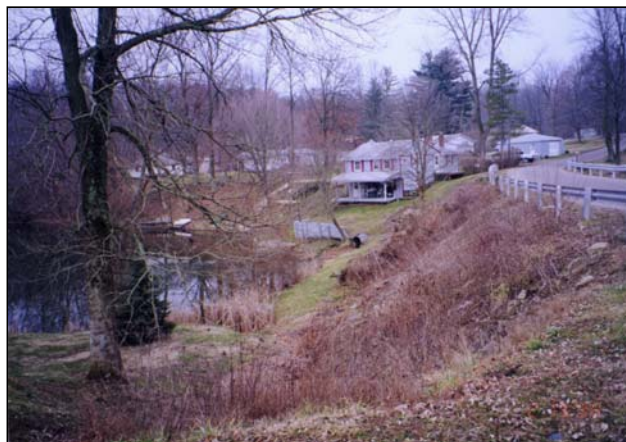
Figure 8-7 Downstream tailwater inundates toe of dam embankment.

Downstream channel obstructions, including dams, can have an impact on the discharge from the dam if the new facilities are close enough. Tailwater that backs up from dams and other obstructions during floods, may reduce the discharge capacity of the upstream dam, especially if the upstream dam has a conduit spillway. The hydrologic and hydraulic calculations for the new features, if performed, should take the upstream dam into account. Tailwater from obstructions should be carefully evaluated to determine if it will impact the upstream dam discharge structures.

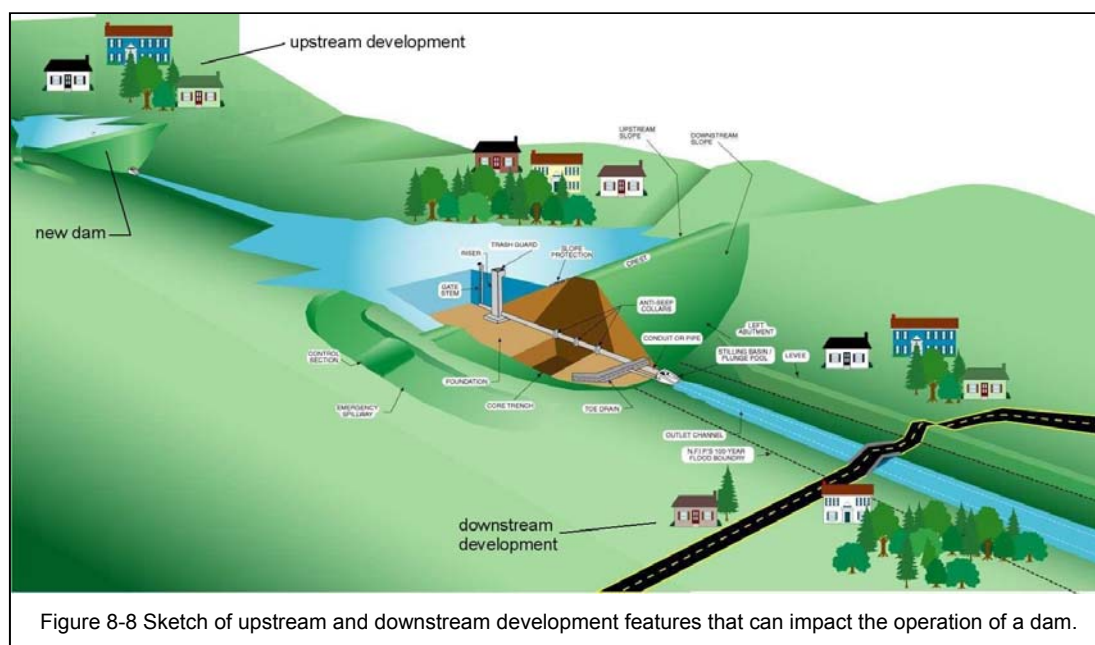
Figure 8-8 Sketch of upstream and downstream development features that can impact the operation of a dam.

Downstream development may create new safety hazards for the dam owner in the event that the dam would fail. New houses, roads, and other buildings that are occupied by people may change the hazard classification of the dam if these features are within the area which would be inundated if the dam failed. New features must be reported to the owner immediately upon their identification.

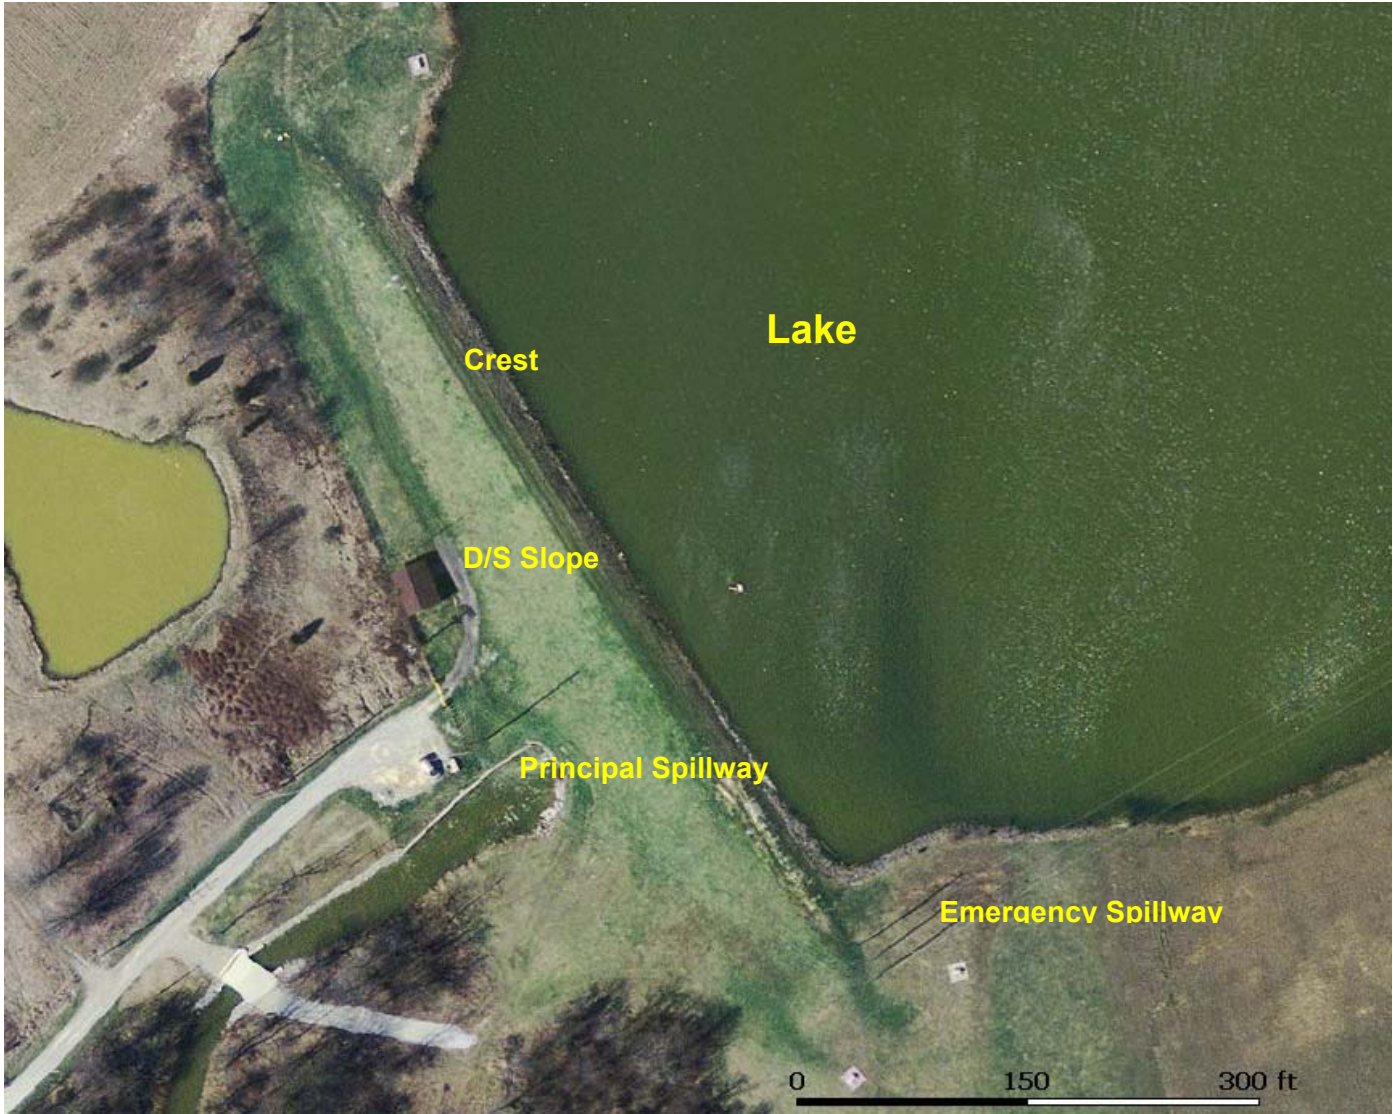
SKETCH OF DAM EMBANKMENT

Note: Inspector should indicate location and configuration of spillways on the plan.
